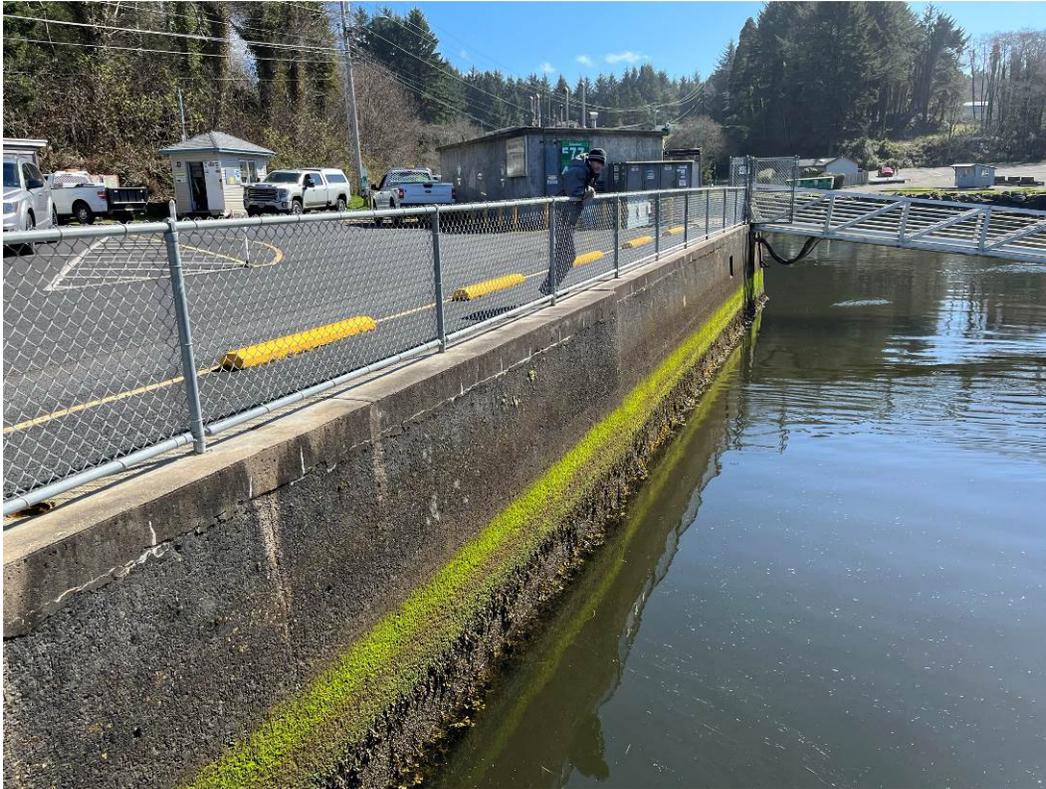
Photo 1 – Existing Seawall

The seawall is showing signs of instability and the U.S. Army Corps of Engineers is working to evaluate and address repairs as needed. Any new access points will need to account for USACE plans as all the ramps are connected to the existing seawall (*see Photo 1*).

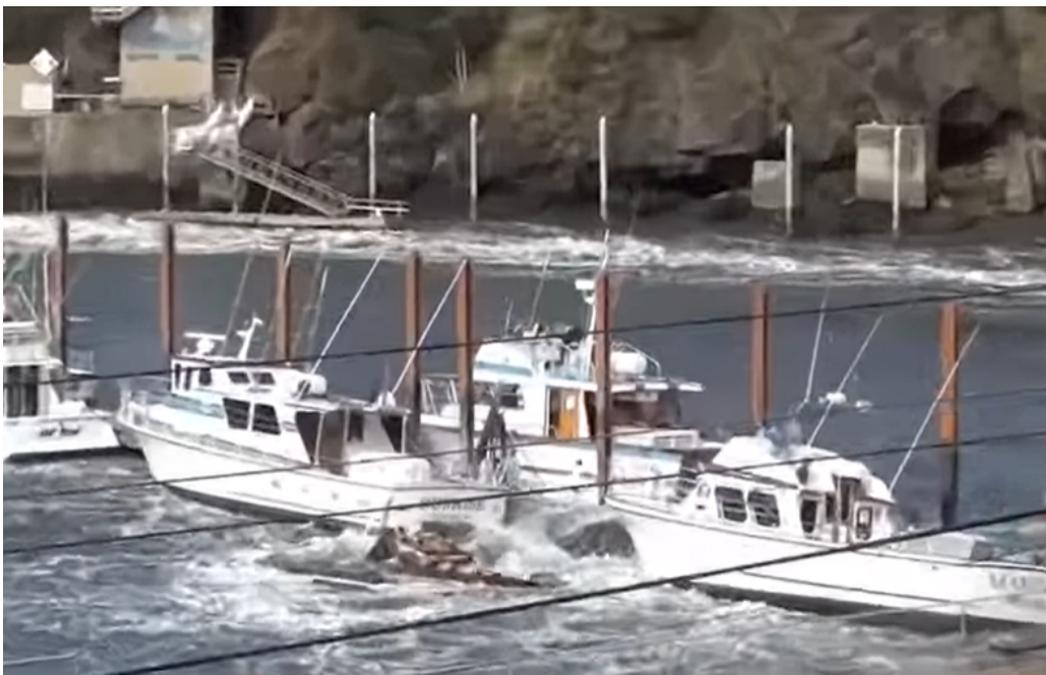
Photo 2 – Screenshot from [Depoe Bay Tsunami, 3/11/11 - Bing video](#)

Preliminarily, analysis will be based on review of video taken during the 2011 tsunami that struck and damaged many of the ports along the West coast (*see Photo 2*). Analysis and visual approximations will be made of the delivered forces from this event and used for design assumptions. Additional resources will be explored, such as any Oregon State University, U.S. Army Corps of Engineers, and other research studies to verify assumptions. Initially, it is anticipated that loading will be modeled as a sustained, high velocity, static water flow.

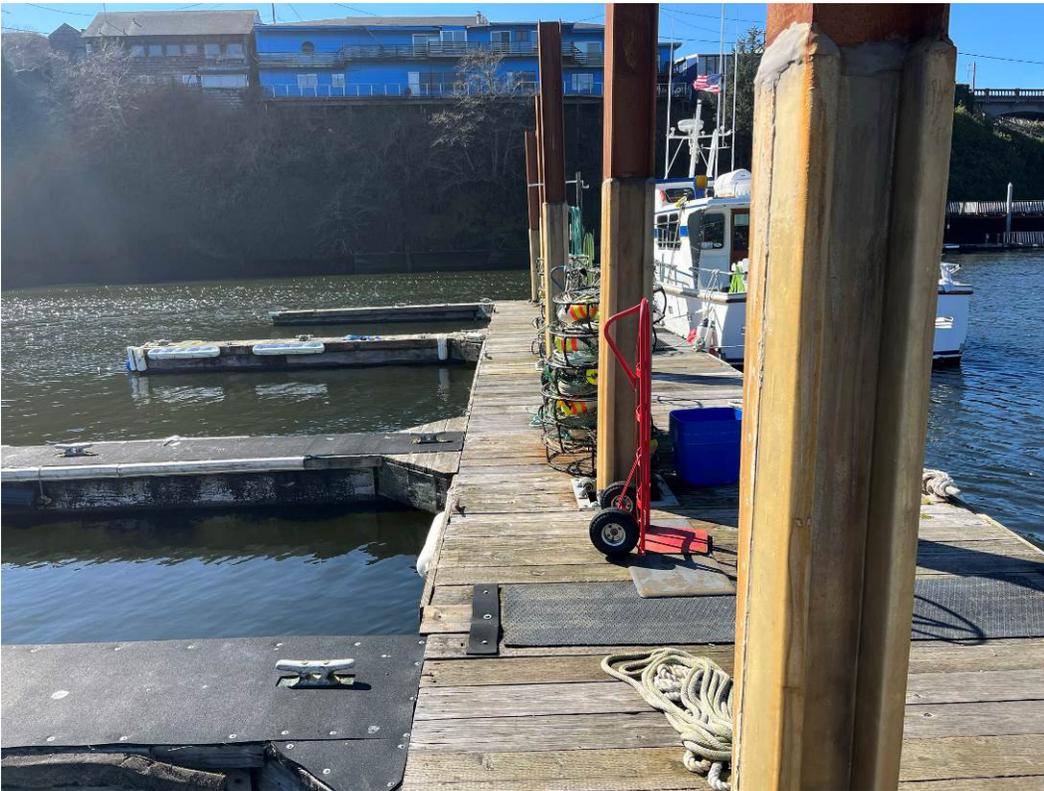
Photo 3 – Steel H-Piles (attempt at corrosion protection)

Most of the existing float anchor piles are H-piles that have suffered extreme corrosion and mechanical damage over time. H-piles are inherently susceptible to this kind of damage because they have far more exposed surface area than an equivalently sized pipe pile. Additionally, H-piles have two axes of bending (a strong direction and a weak direction), which is not ideal in a float anchor system, where loads may act from any direction. A similarly sized pipe pile, with similar weight and section modulus equivalent to the strong bending direction on the existing H-pile would be a 12.75" diameter x 0.5" wall pipe pile. The pipe pile has 33 percent less surface area exposed to corrosion and has more bending strength in any direction than the H-pile in its strongest axis. In short, it is strongly recommended that any new piles be galvanized steel pipe pile, appropriately sized for the design forces.

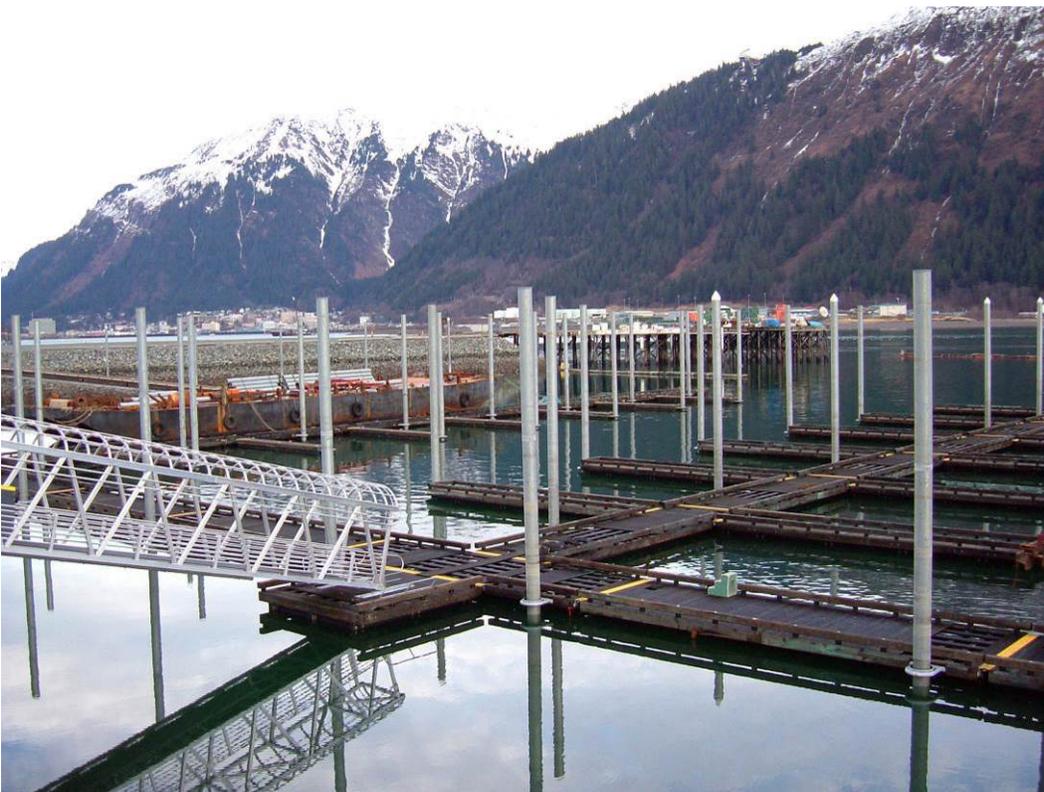
Photo 4 – Timber Floats

A variety of float materials were discussed in the concept report including timber frame (*see Photo 4*), concrete (*see Photo 5*), aluminum frame (*see Photo 6*), steel frame, and High-density polyethylene (HDPE) pipe systems (*see Photo 7*). Deck options include grating (fiberglass, aluminum), concrete, timber, and plastic lumber. Floatation materials include enclosed steel pipe (*see Photo 8*) or HDPE, filled with EPS (expanded polystyrene), EPS filled polytub billets, and concrete encapsulated EPS. The choice of materials requires a thorough analysis of design conditions, desired performance, operational life, level of maintenance, agency restrictions (environmental permitting), and initial cost. Each material construction type has its advantages and difficulties, including effects on anchoring systems and ease of construction and utility installation.

A timber framing system may still be permissible. However, the timber will need to be treated and the product must be sealed to prevent leaching into the surrounding bay. The regulatory restrictions will also prohibit timber for use as float rubstrips as this contact may result in treated timber in the water.

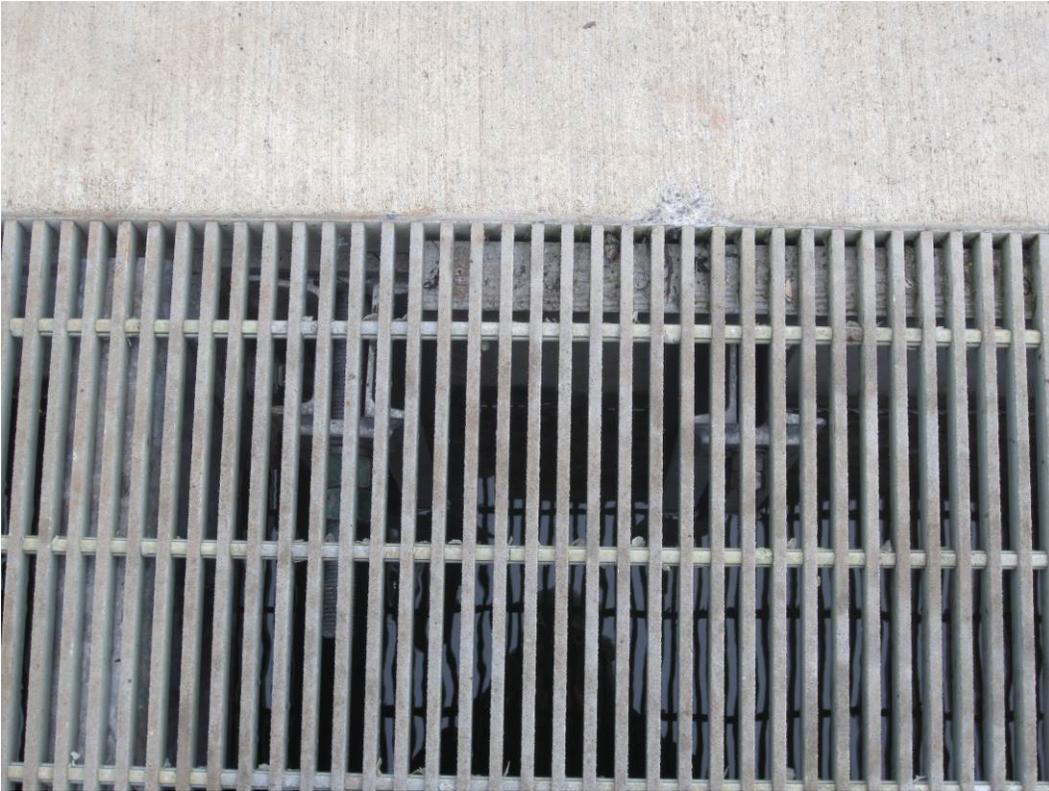
Photo 9 – 60% Open Area and ADA Grating

Solid dock surfaces will require mitigation. Permitting agencies prefer docks wider than 6 feet to have at least 50% of the surface composed of grating containing at least 60% open space (*see Photo 9*). Floating dock wider than 6 feet without grating will require mitigation to offset the large, covered area. PND recommends grating over a portion of the 10-foot wide docks to limit the amount of mitigation required for the project and streamline the permitting process.

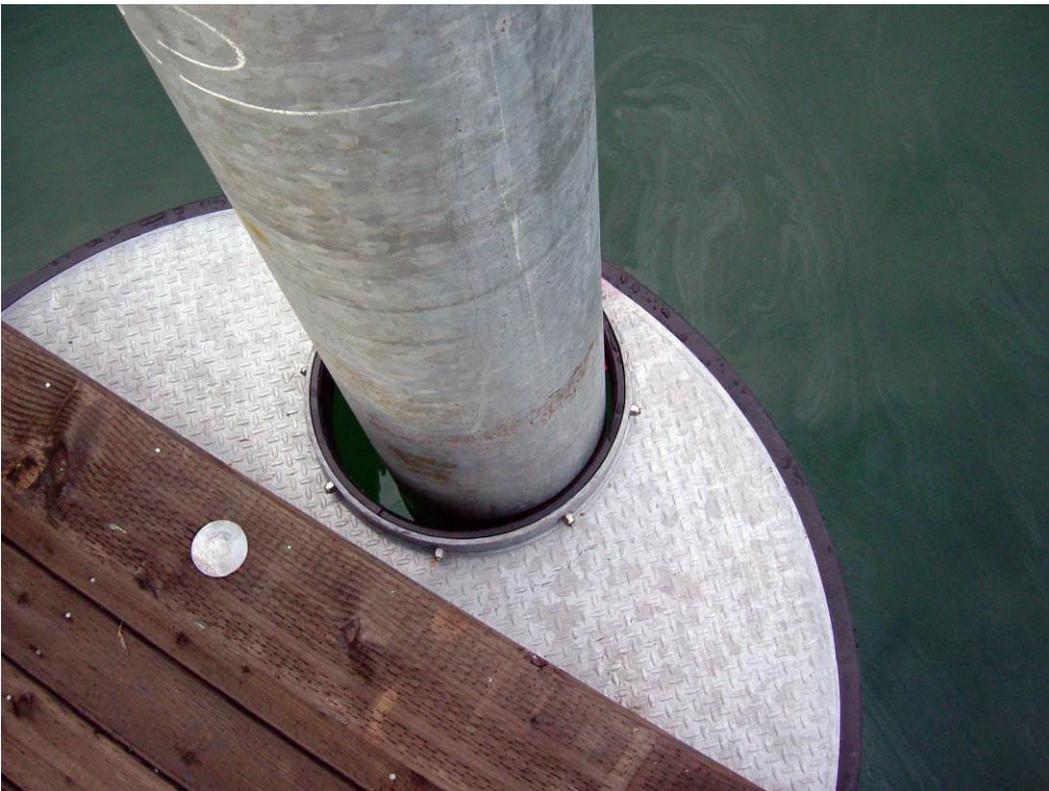
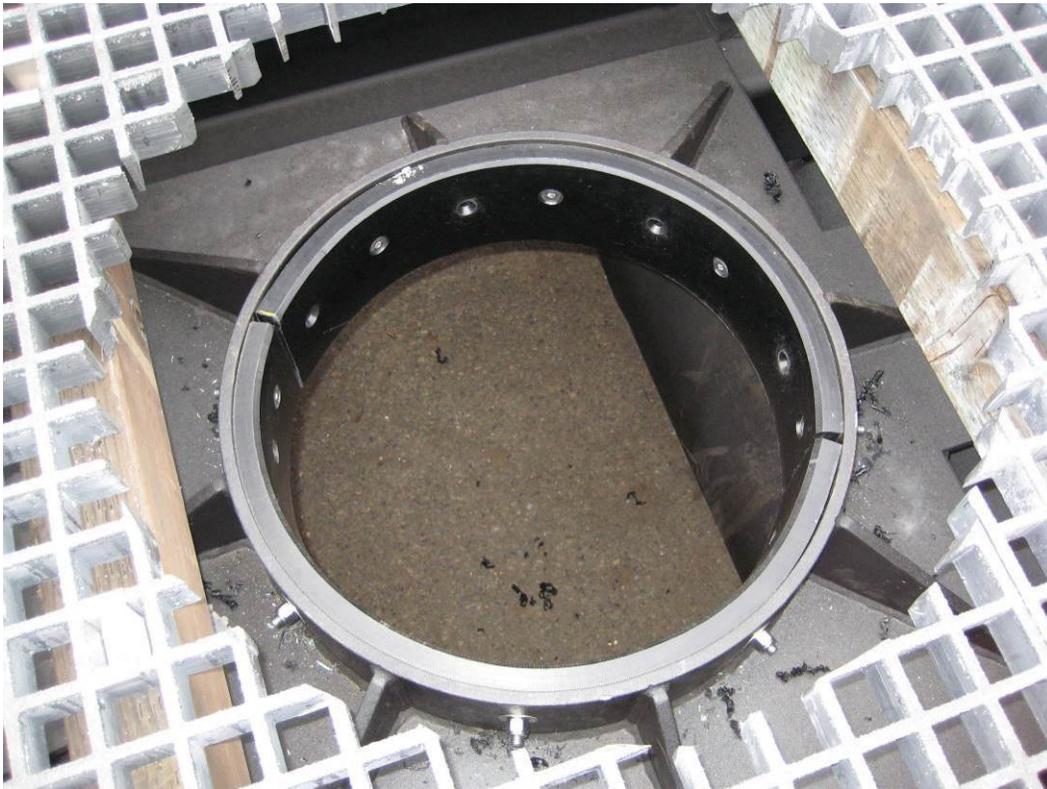
Most of the existing pile are driven through internal frame hoops, running down the centerline of the main walks. None of the fingers have pile hoops. Internal pile hoops make it difficult to modify and/or remove docks. Additionally, piles down the middle also consume valuable dock surface. Moving the piles to the edge helps reduce deck obstructions, while also facilitating install, etc. If dock fingers remain on the main walk permanently (see above paragraph) the pile hoops could be attached to the outside of edge, midway between finger floats without being a vessel berthing obstruction. If side tie spaces remain a priority, the pile hoops could be placed on the opposite side of the main walk from the side tie side. The type of float system employed will help inform the best type of pile hoop to use. Structurally, pile hoops are designed for appropriate design loading using steel or aluminum. Using UHMW-PE rubstrips that provide a low friction sliding surface for the pile to slide tends to perform better and with

less maintenance than rollers. The rubstrips should be placed in the hoop to mimic the shape of the pile with consistent spacing to avoid binding and uneven rubbing (*see Photos 10 and 11*).

Photo 10 – Pile Hoop at End of Finger Float

Photo 11 – Pile Hoop Internal Frame (prior to final deck fit up)

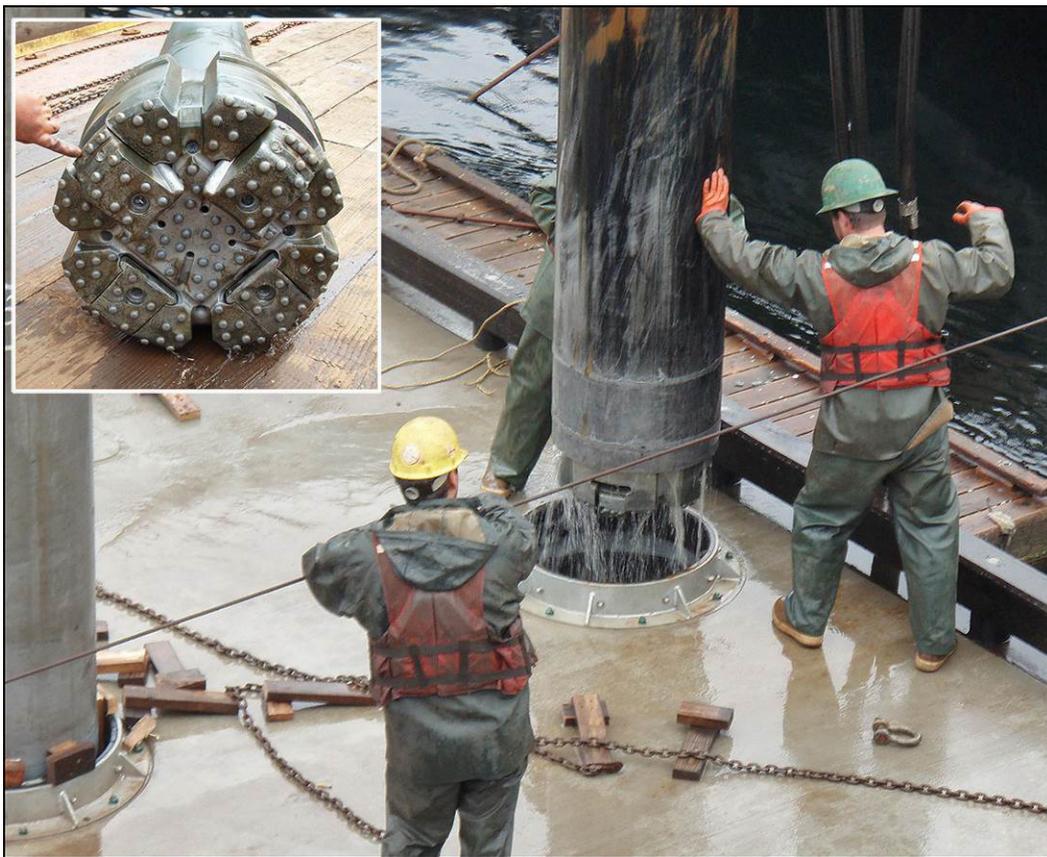
Photo 12 – Drilling Equipment for Socketing Piles

Cursory consideration of geotechnical information (primarily verbal descriptions at this point) suggests that the basin consists of a rather shallow layer of sediment, overlaying a very dense layer of mudstone and sandstone. This will need to be verified and analyzed in detail for pile design to commence. USACE has historic borelogs associated with the seawall and is scheduled to perform additional geotechnical borings in the parking lot in April. PND has made contact with USACE to coordinate this information. Given the anticipated large current forces at the site, pile socketing into the dense layer may be needed (*see Photo 12*) though impact driving may be adequate to achieve embedment (*see Photo 13*).

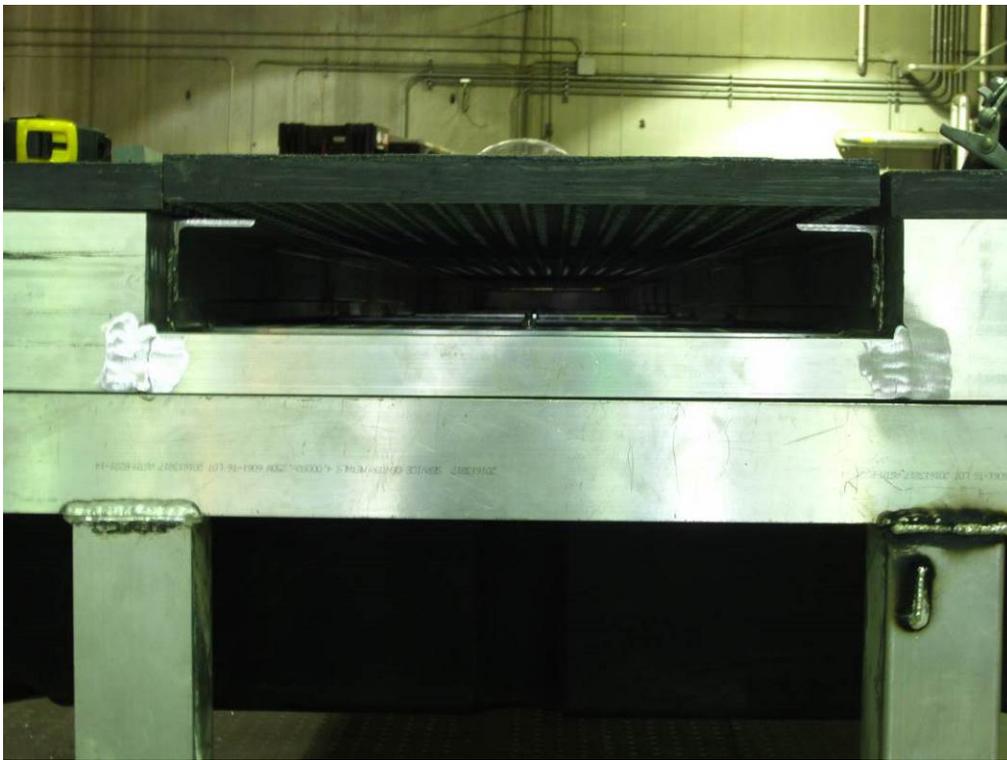
Photo 14 – Utility Chase with Removable Deck Panels

Harbor staff requested that all utilities be accessible from the deck surface for easy access. Thoughtful float design, using removable deck panels to access utility chases, should be part of any dock design (*see Photo 14*). Also, providing frequent isolation valves to reduce service interruptions during repairs should be included.

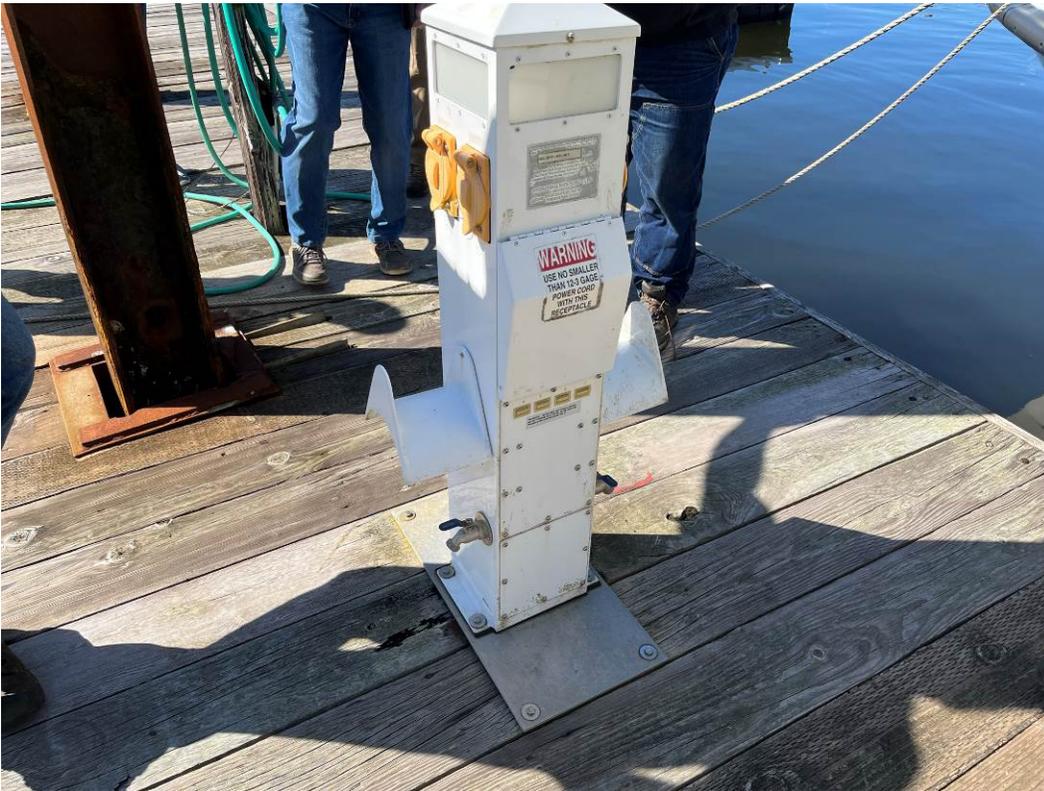
Photo 15 – Utility Pedestals with Potable Water

The City would like to have potable water integrated into the electrical utility pedestals (*see Photo 15*). According to the concept report, no fire suppression system is required on the docks. This should be verified to ensure the fire department is not going to require this as part of the new dock system.

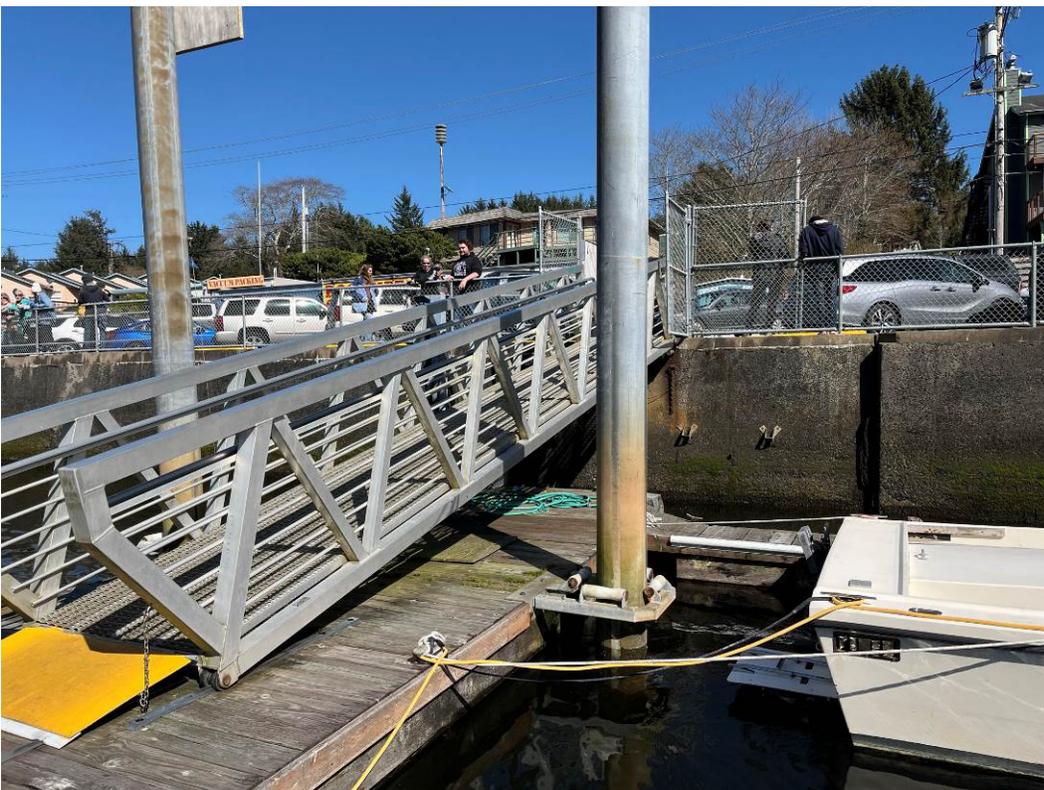
Photo 16 – Existing Gangway Ramp

Currently, docks 2, 3 and 4 are each accessed by their own 28-foot long aluminum gangway ramp (see *Photo 16*). The ramps are attached to steel hangers attached to the seawall. The top of the seawall is at an elevation of about +13' Mean Lower Low Water (MLLW). The water elevation varies from about -4.5' to as high as +13' placing the dock surface anywhere from -3' to +14.5'. At low tide, the 28-foot long ramp has an extremely steep slope (Slope Grade ~70%). At high tide (exacerbated by frequent surge events) the lower end of the ramp high centers on the end of the floats and lifts off the deck. Both of these conditions are problematic.

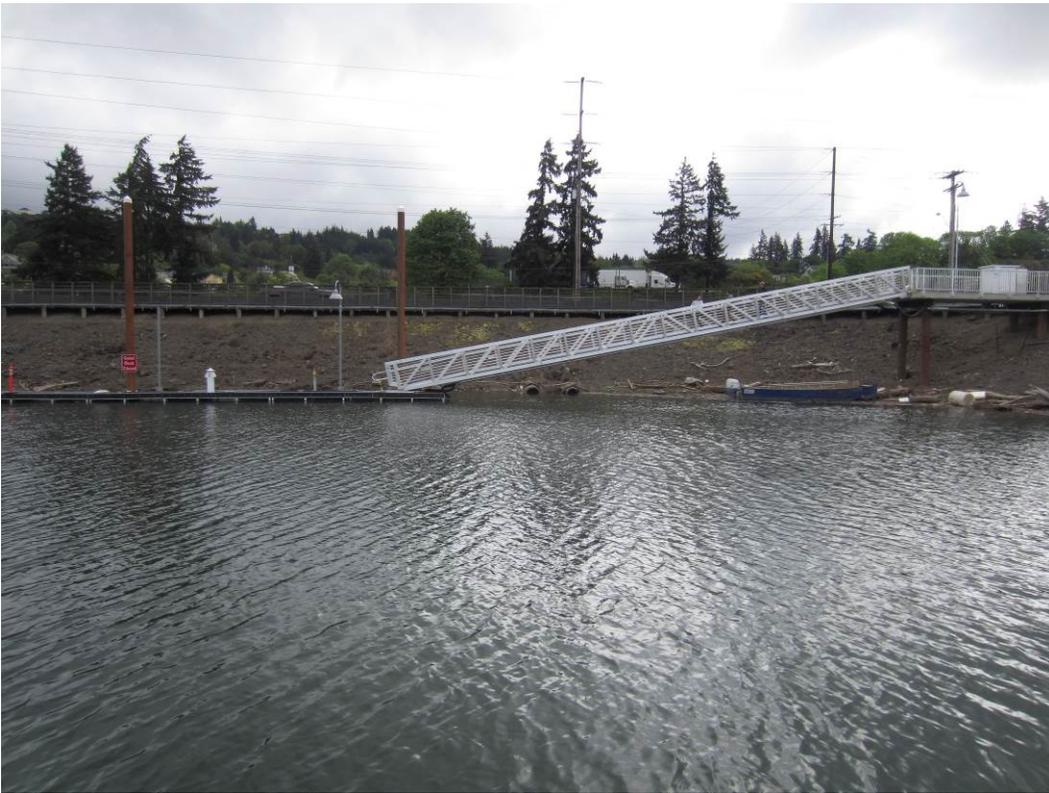
Photo 17 – 80-foot Long ADA Gangway Ramp (Port of Kalama)

None of the ramps provide ADA access to the docks. It is recommended that at least one of the docks be upgraded to meet ADA accessible standards. This will include replacing one of the 28-foot ramps with an 80-foot ramp and new fixed approach pier (see *Photo 17*). Rather than lay the new, longer gangway down the middle of the main walk, and consuming deck space and reducing access to part of the dock, a new landing float could be added. The gangway ramp would run parallel to the seawall from the new approach pier. As mentioned earlier, in the **Dock Layout** section, this would allow for some freedom to adjust the spacing of one of the docks and optimize layout options, while also providing an ADA facility.
